Date: November 11, 2000
Subject: Hackberry Pits
From: OSC Robert M. Ryan, P.E., U. S. EPA Region 6
To: Director, ERD
Charles A. Gazda, Chief, RPB, Region 6

A. Incident Category: Abandoned Oil Production Facility

Facility 12-E-1001, identified as the Hackberry Pit No. 1, is located in the East Hackberry Oil Field, within the Pete Seay Circle Road (Rd) residential area of Hackberry, Cameron Parish, Louisiana. The pit is located approximately 400 feet (ft.) south of Black Lake Bayou and 0.5 miles west of the Calcasieu Ship Channel. The facility is mapped in the Moss Lake USGS 7.5-minute quadrangle, within Section 37, Township 12 South, Range 10 East. The geographic center of Pit 1 is at Latitude 30° 00' 12" North and Longitude 93° 20' 27" West. The facility is accessible by land only. To reach the site, travel 700 ft. south on Highway 27 from Black Lake Bayou and turn left onto Pete Seay Circle Rd. Travel approximately 1,000-ft. on the north side of Pete Seay Circle Rd. and the pit will be located approximately 40-ft. to the south.

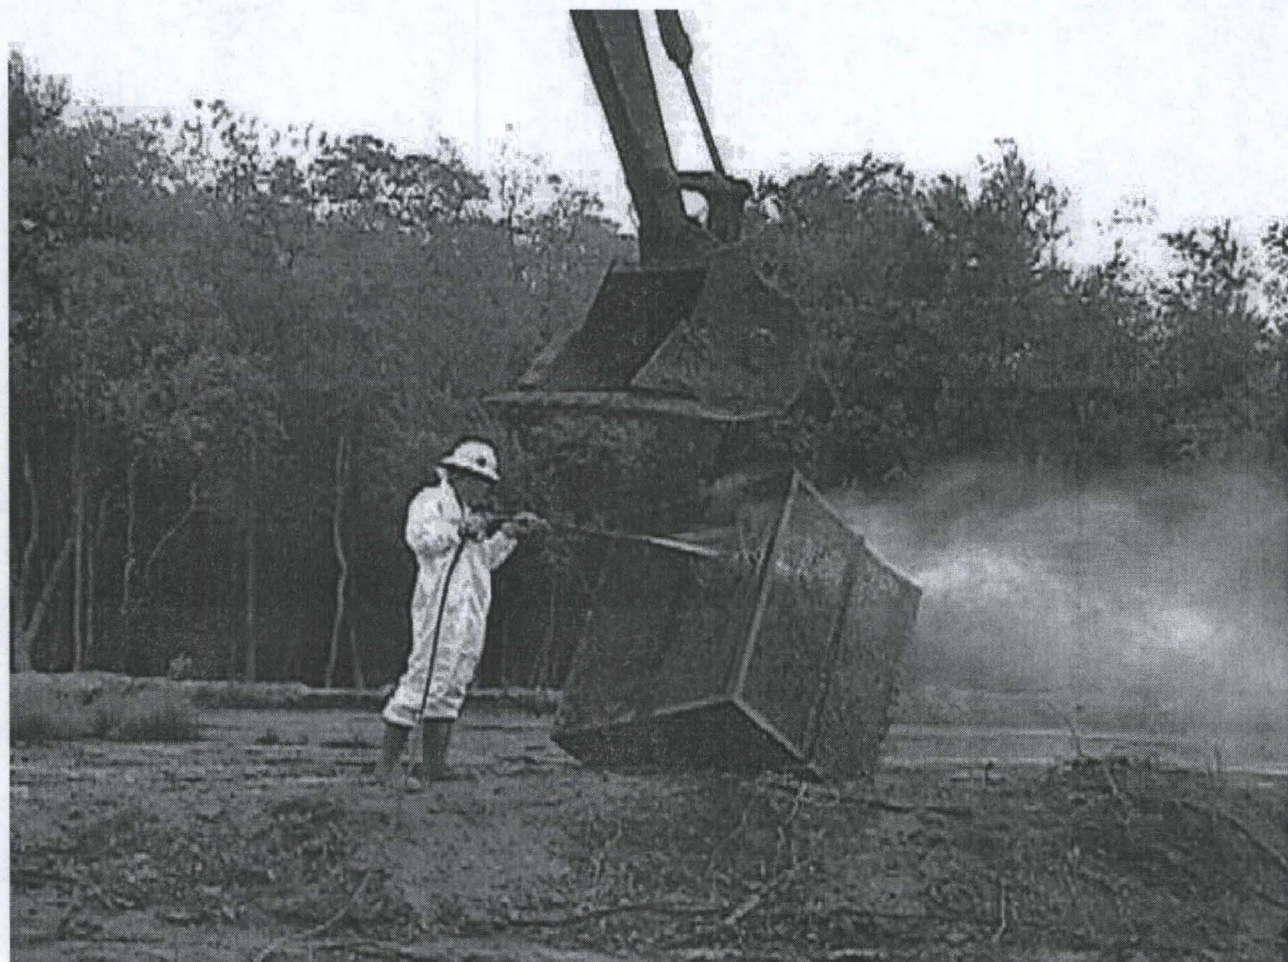
HackberryP4-pic1.jpg	Decontamination of metal basket.
HackberryP4-pic2.jpg	Mixing pit sludge with long reach excavator.
HackberryP4-pic3.jpg	Water treatment unit (sand and carbon cells).
